Manhole Inspection Summary

Manhole # S06YY1009MH

Location Address: **4020 CLARKS LN**

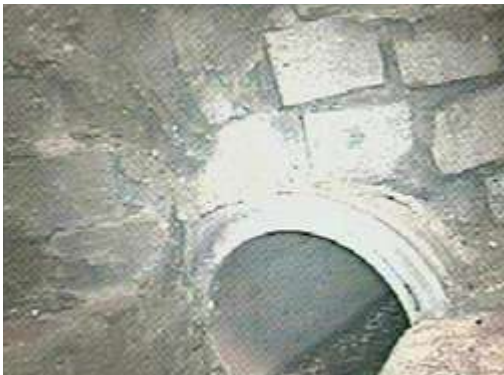
Missing Bricks or evidence of pluge

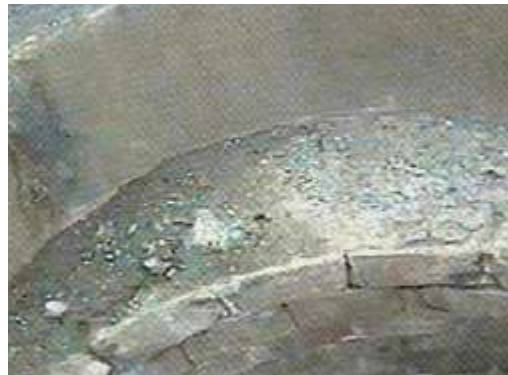
Defect

☒ **Leaks**

Condition: ☐ Sound ☐ Cracked ☐ Root Intrusion ☒ **Loose Brick** ☐ Deteriorated

Infiltration: ☐ None ☒ **Joint** ☐ Cracks ☒ **Mortar** ☐ Roots ☐ Wall

Frame leaks. Frame offset. Adjustment loose brick and infiltration.

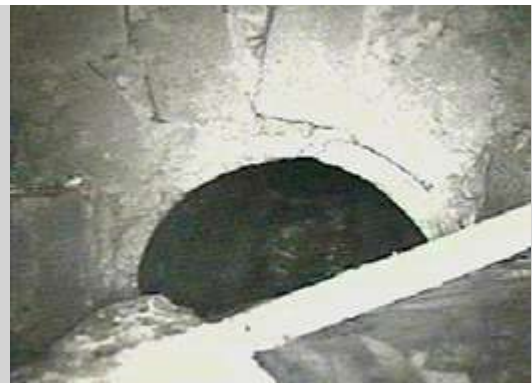
Pipe Out @ 12 O'Clock

Deposits: ☐ None ☐ Mud ☐ Sludge ☒ **Debris** ☐ Grease

Silt Depth: **2** (in.) Deposits Extent: **Medium**

Infiltration: **Evidence** Pipe Seal Cond: **Cracked**

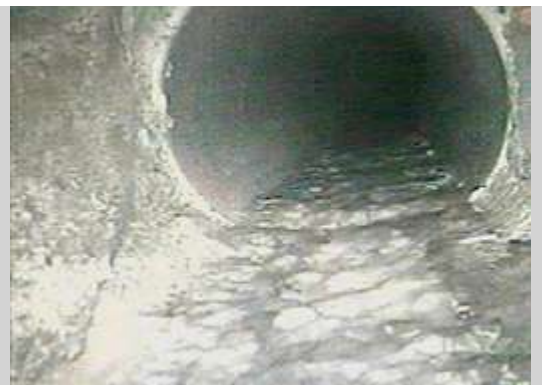
Pipe In @ 6 O'Clock

Deposits: ☒ **None** ☐ Mud ☐ Sludge ☐ **Debris** ☐ Grease

Infiltration: **None**

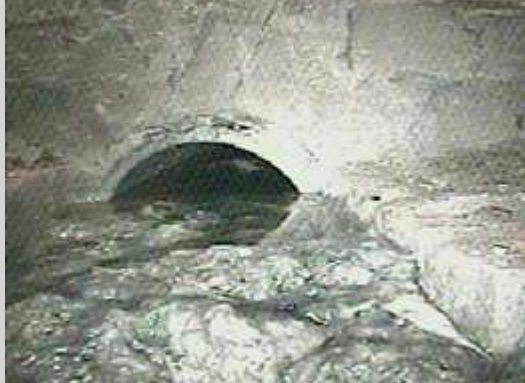
Pipe In @ 9 O'Clock

Deposits: ☐ None ☐ Mud ☐ Sludge ☒ **Debris** ☐ Grease

Silt Depth: **3** (in.)

Deposits Extent: **Medium**

Infiltration: **Evidence**
